## Lessons from other industries

# Passengers killed when their train crashed into wagons carrying flammable oil

Andy Brazier, AB Risk Limited, UK

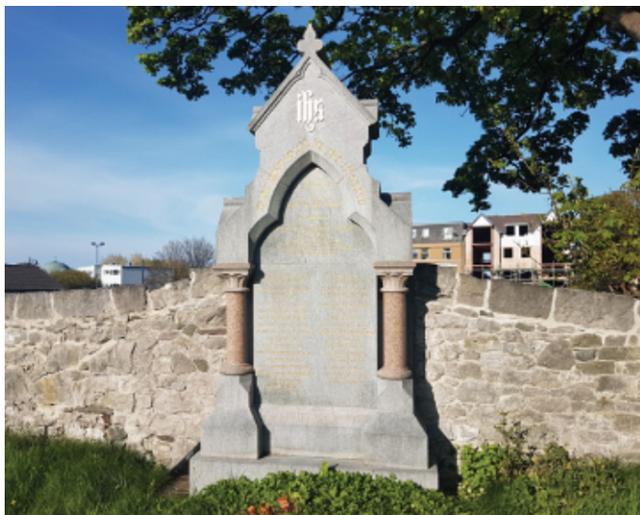
There is a memorial to victims of this disaster at St Michael's Church in Abergele. This is where they were buried in a mass grave. One reason that so many people died in this accident was that common practice at the time was to lock carriage doors. This meant the passengers could not escape from the fire.
